Rapid Inventory of Earthquake Damage (RIED)

Assessment of the damage of
the 25 January 1999 Earthquake
in

Armenia and Pereira, Colombia

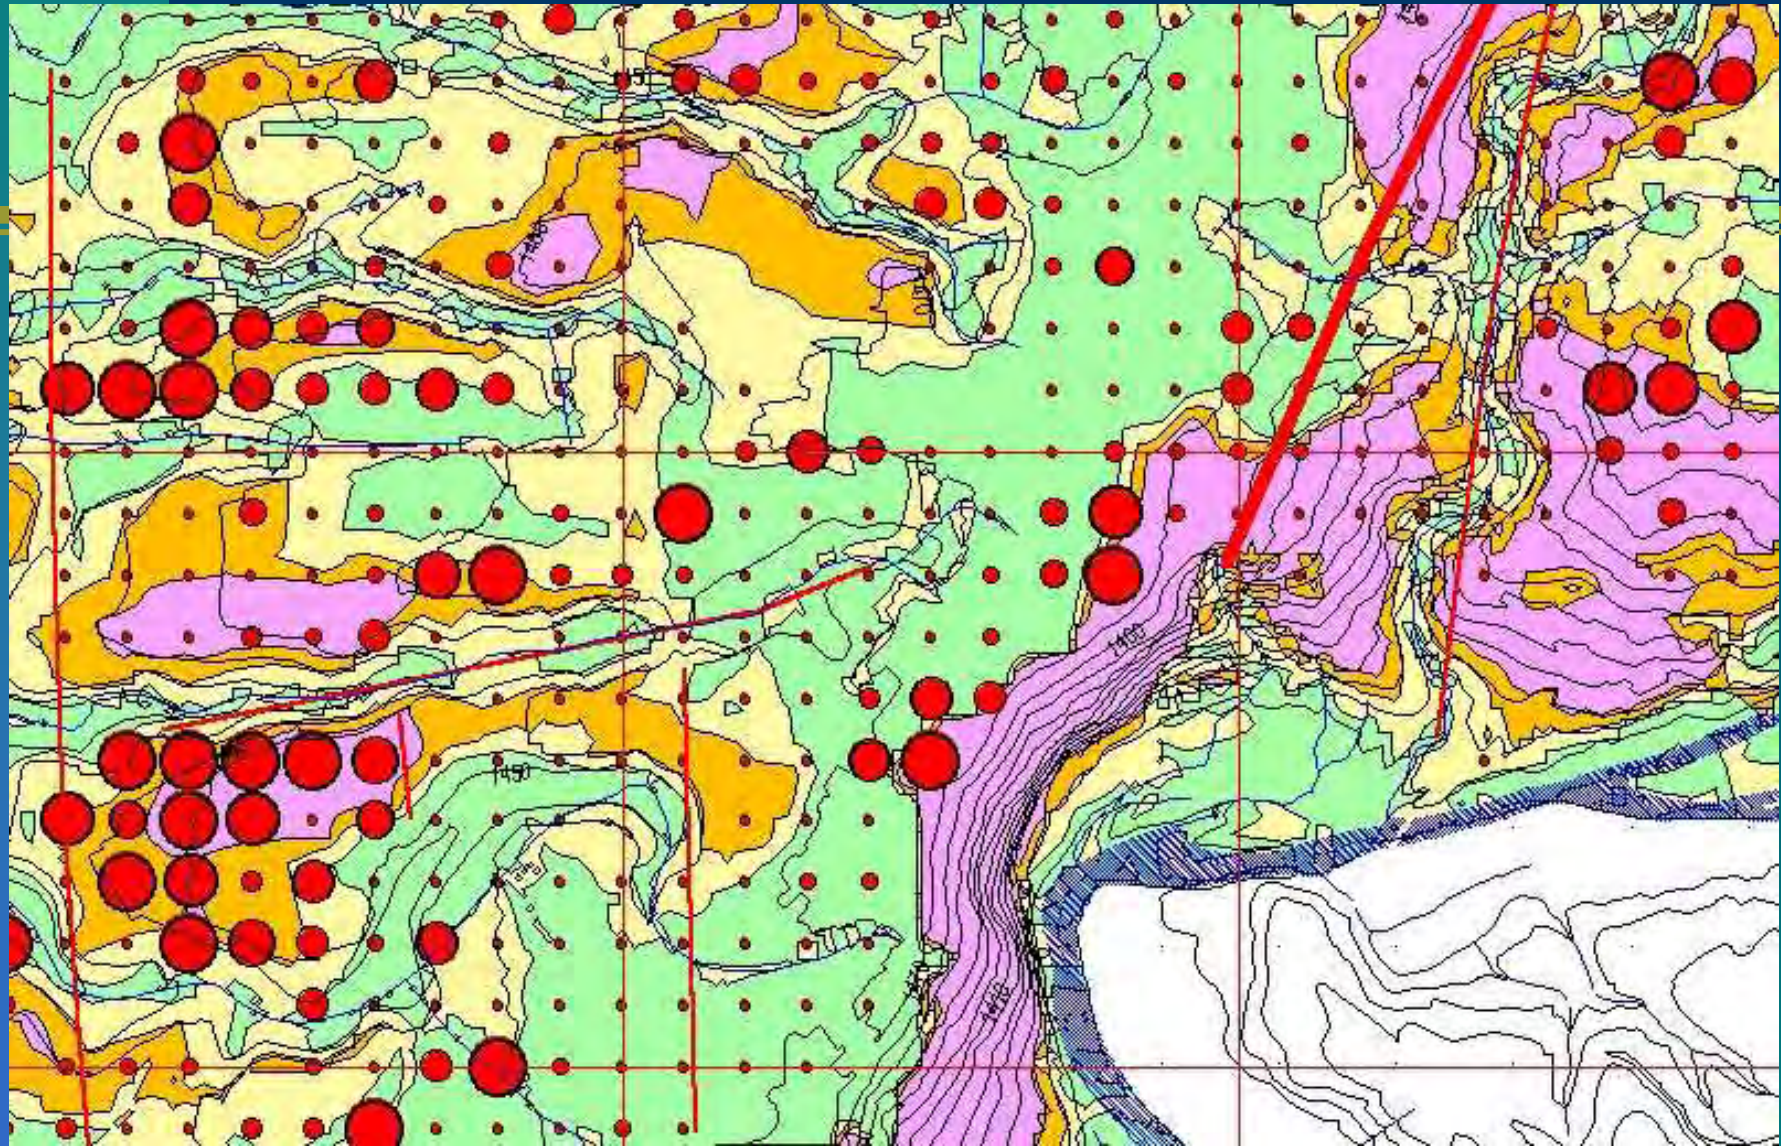
Two-dimensional Topographic Effects

- Qualitative calculation topographic effects
- Correlated with damage pattern

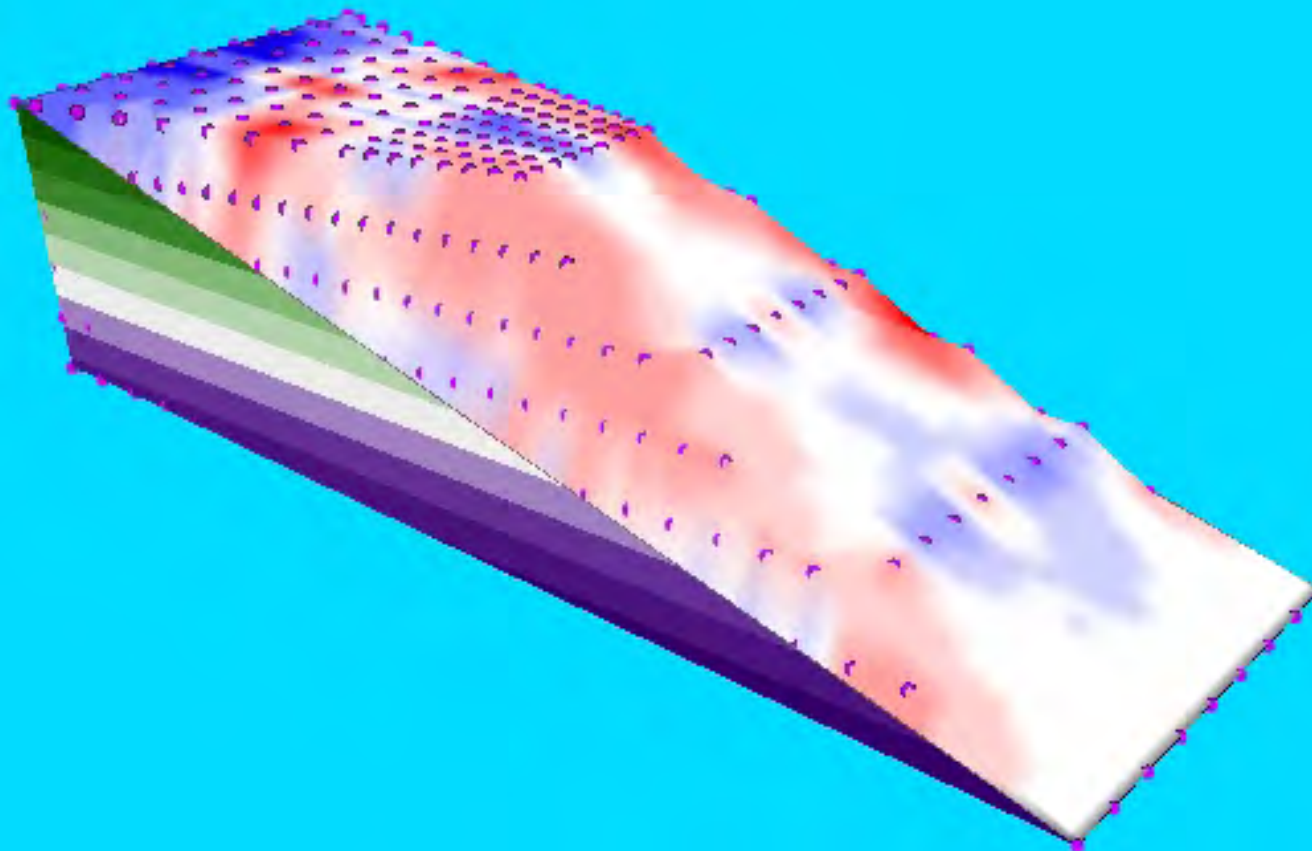
Surface acceleration as result of
3D modeling: red is high; blue is
low acceleration

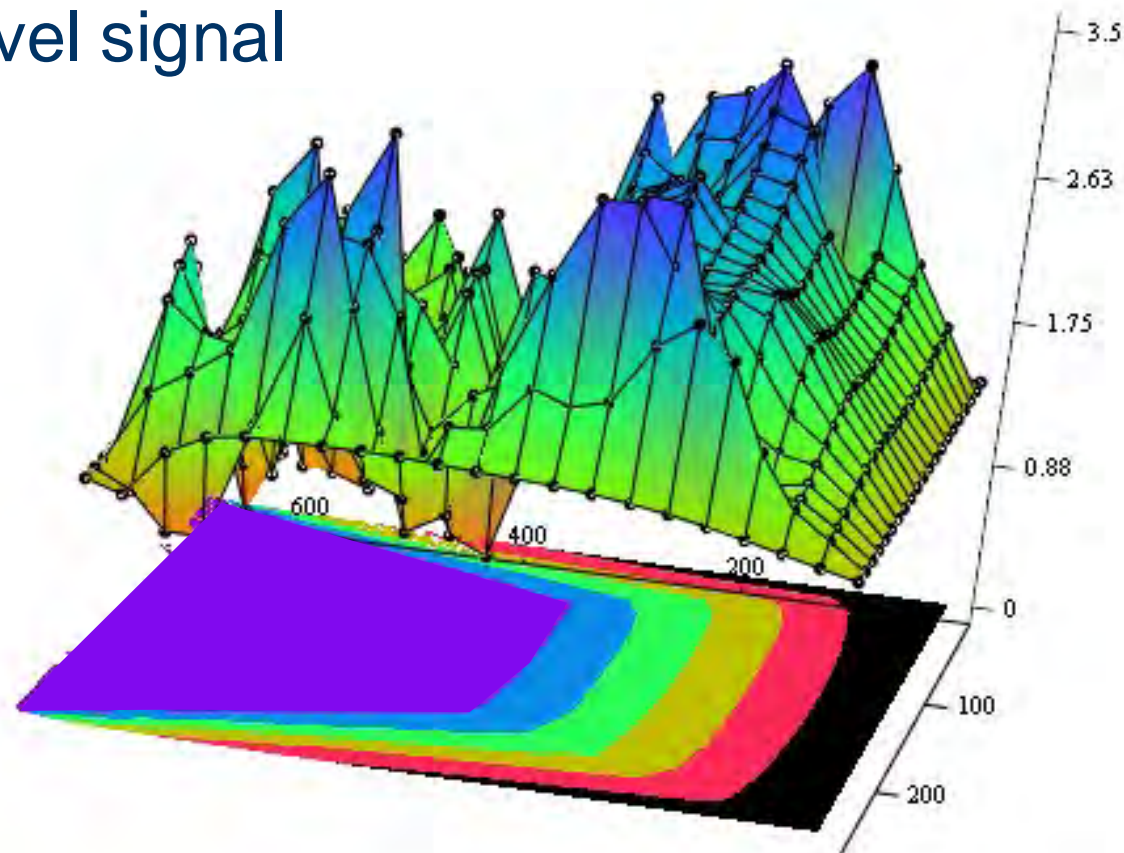
Surface acceleration as result of 3D modeling: maximum acceleration $\approx 3 \text{ m/s}^2$ which is about 3 to 4 times the maximum in the base level signal

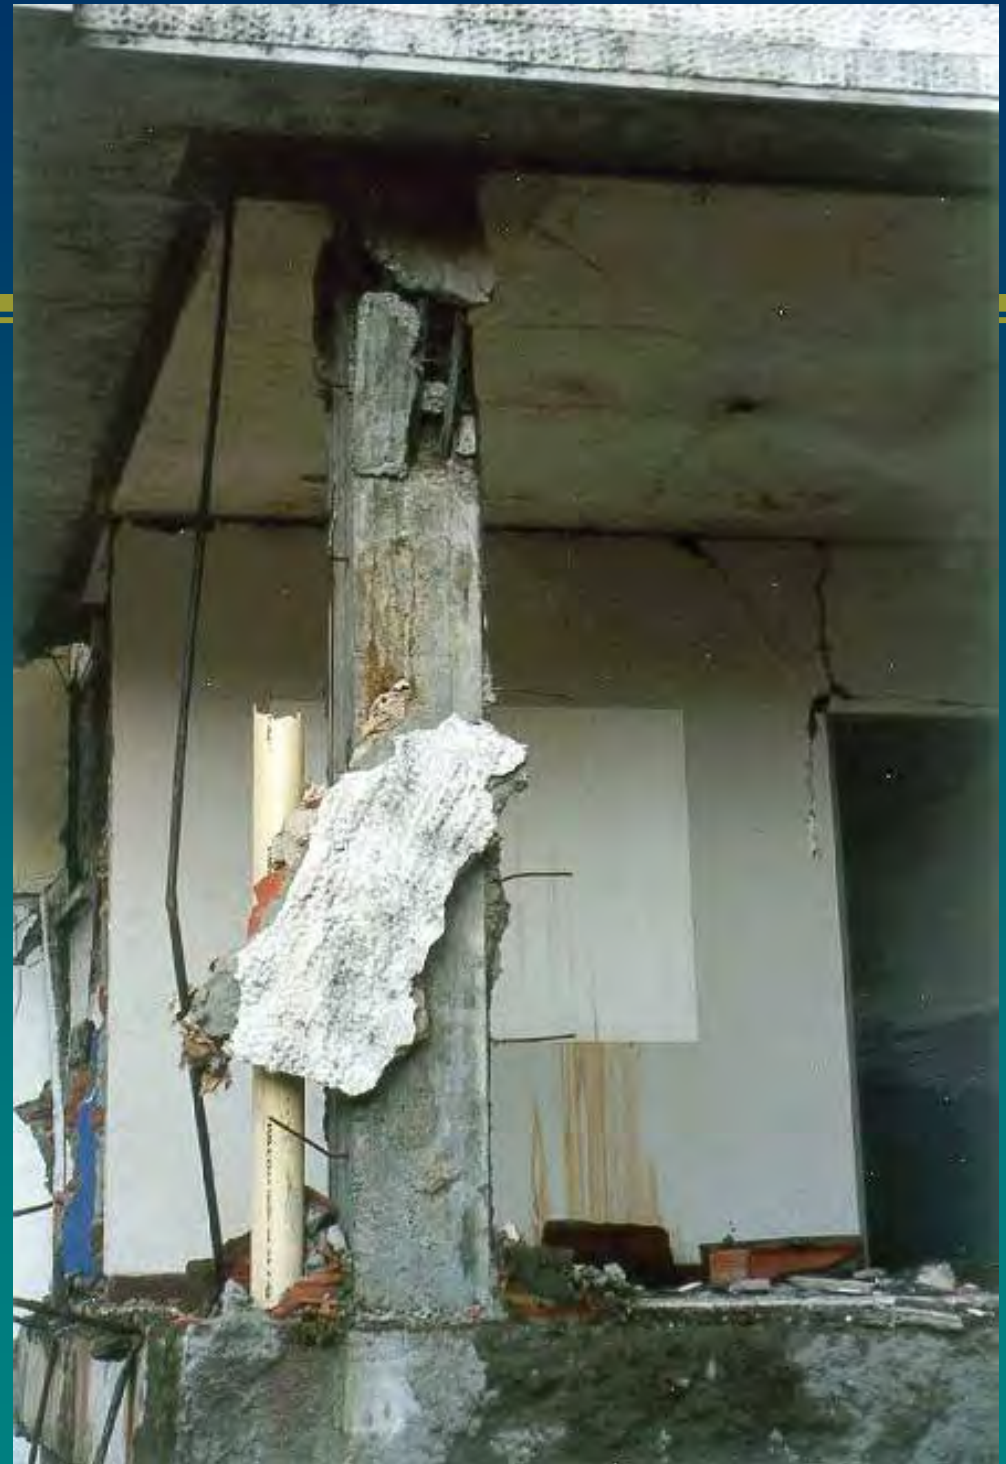
Flat Slabs and Columns

This structural system has been known to be a non-ductile system since the only available energy-dissipating members are the columns.

Solution is weak-beams-strong-columns methodology, usually known as capacity design.

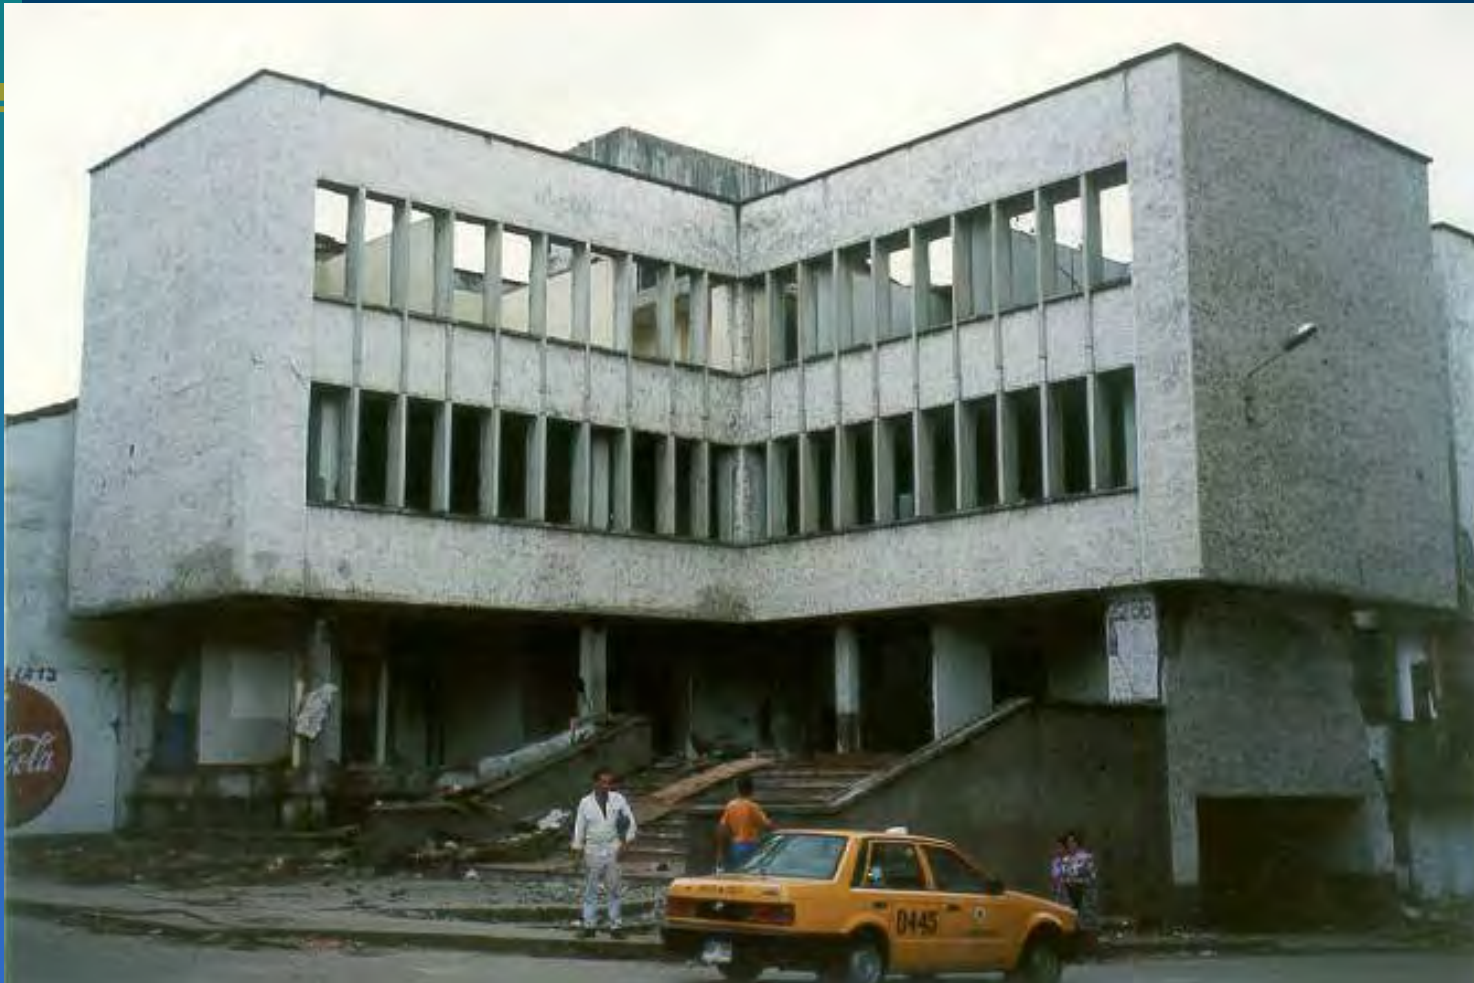
Torsional Resistance

The severe column damages in the columns at the periphery of the building is a strong indication of lack of torsional resistance.

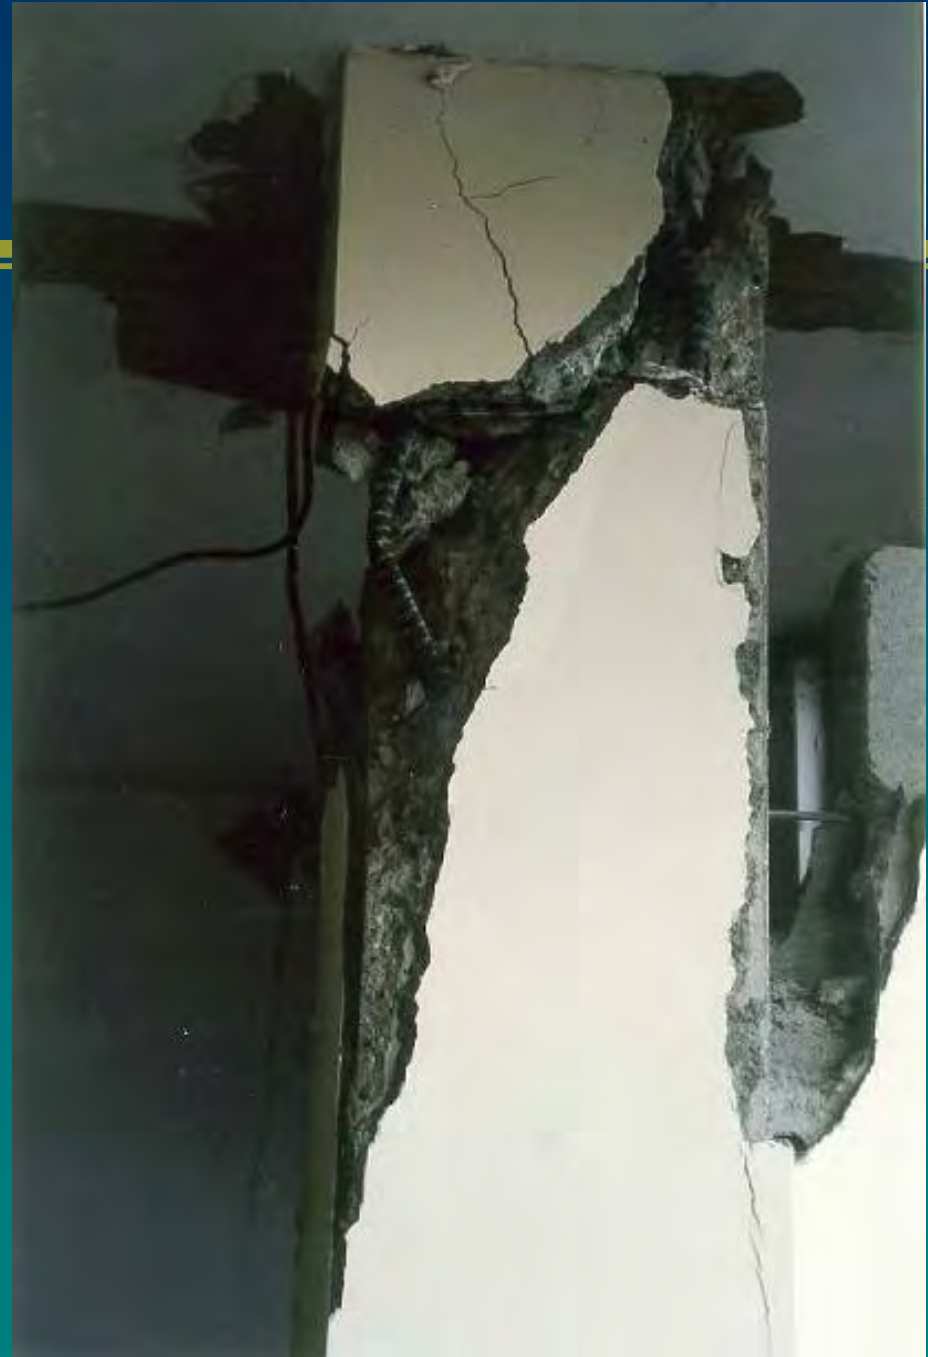
Shear Reinforcement and Lateral Ties

Columns had failed in shear at the points of maximum bending moment due to not adequately anchored shear reinforcement. Frequently, buckling of the main reinforcing bars was also evident. **Lateral ties** were not adequate in providing lateral support to the main bars causing the concrete to be crushed to rubble

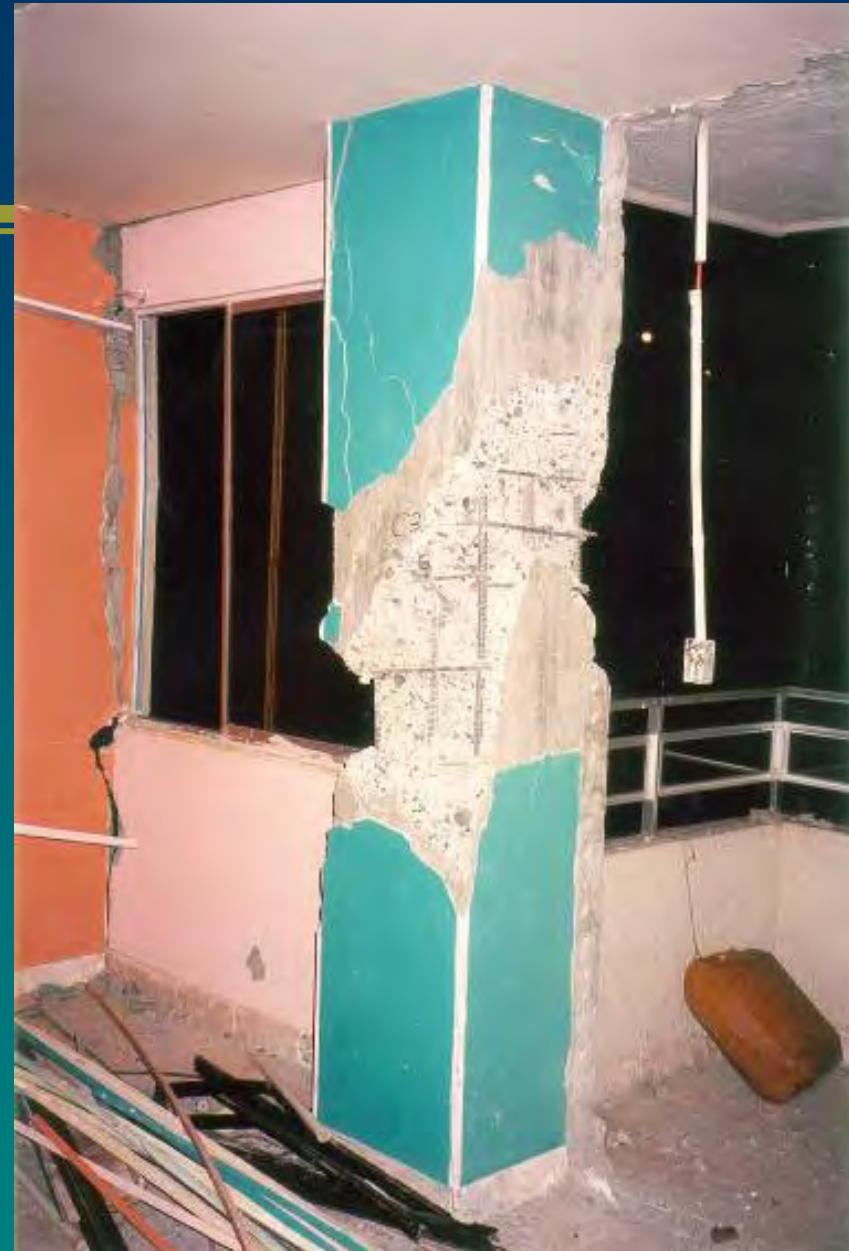
Short-columns

Some typical cases of short-column behaviour were observed. In all of these the reason was the interaction of the column with adjacent (non-structural) elements.

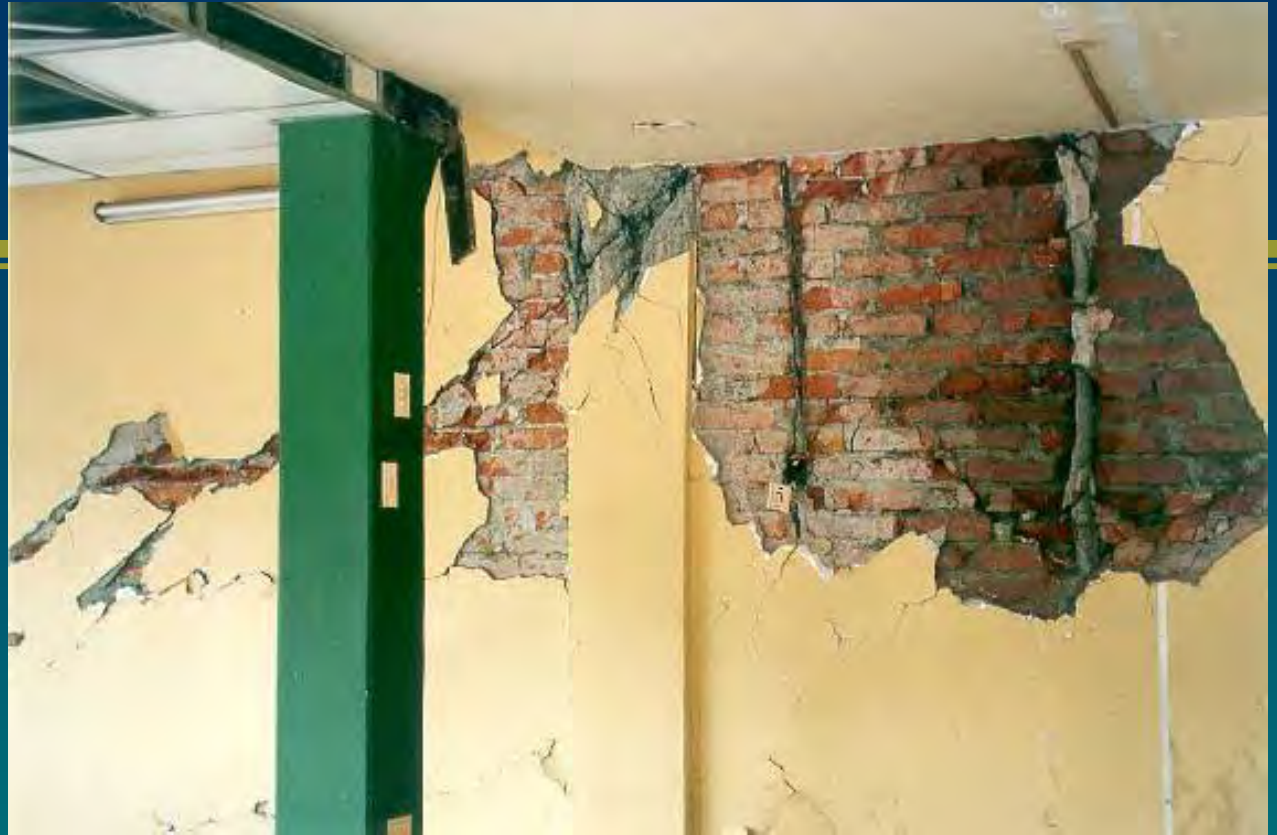
Masonry In-fill

Workmanship problems were observed in the majority of damaged masonry in-fills. As a result, collapse of the in-fill prevented failure of the adjacent columns. In all cases it was observed that the in-fill was constructed totally against the column.

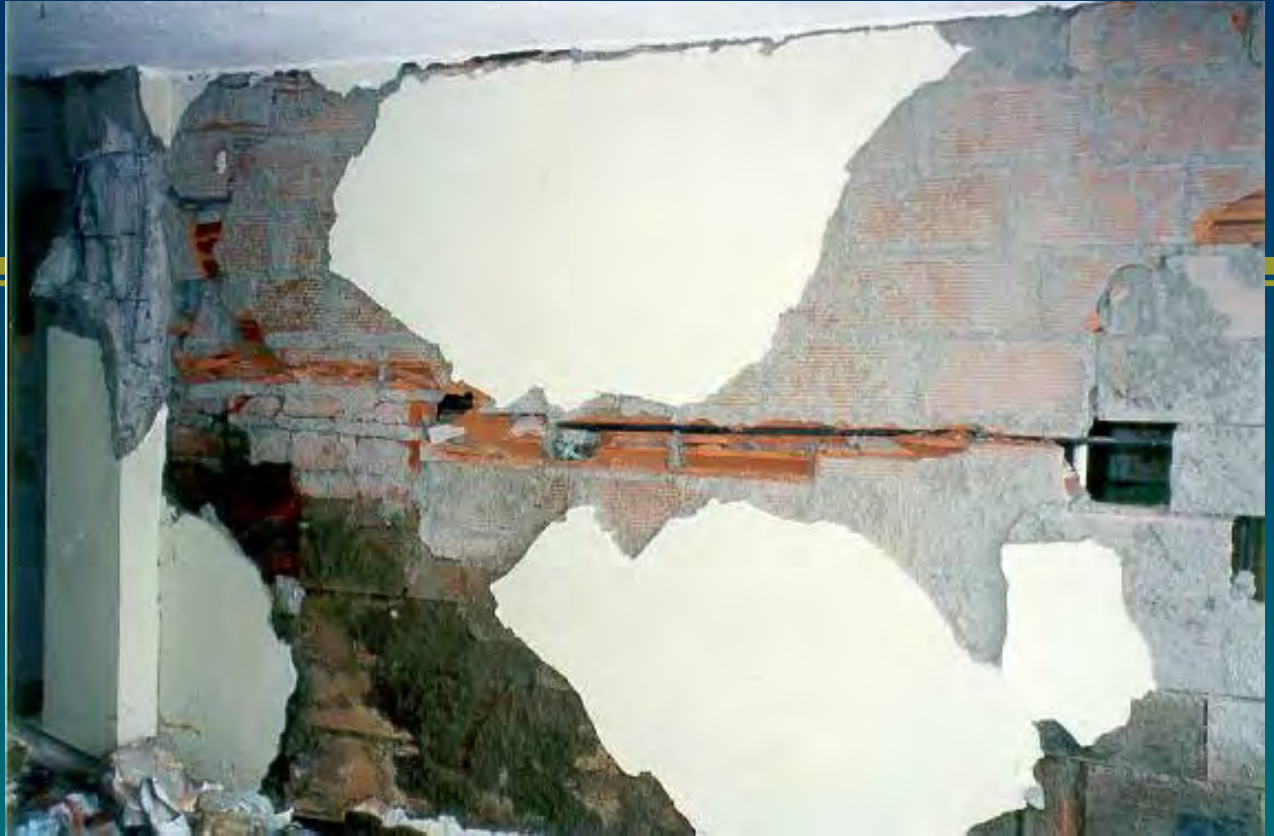
Embedded Utilities

Utility items embedded in the body of the masonry wall. These can create planes of weakness in the body of the wall which can then fail by slippage. In one case, slippage failure of the wall had clearly resulted to shear failure of the adjacent column.

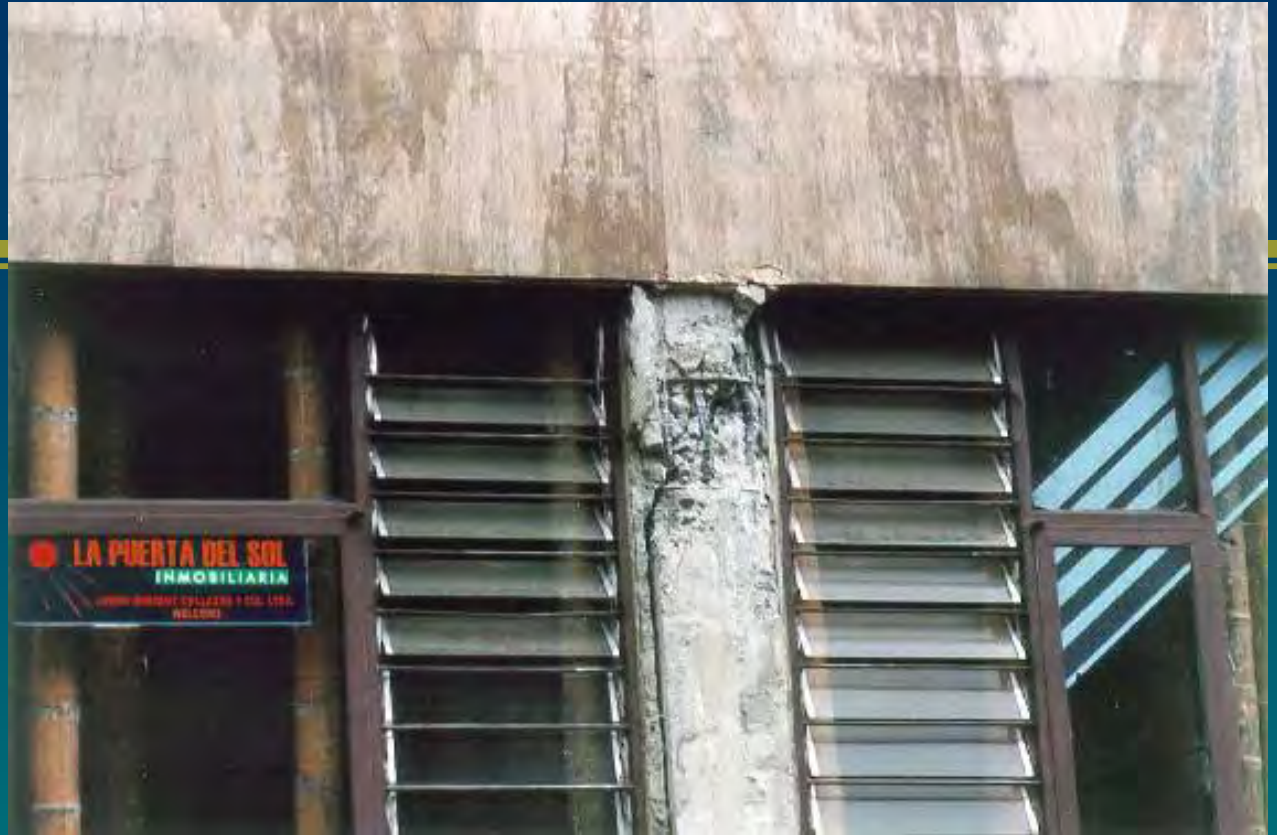
Soft-stories

Soft-storeys. The reduction of the stiffness at a certain level of the building, typically at one of the bottom floors, results in severe damage in the top and bottom of vertical structural elements due to lack of lateral reinforcement.

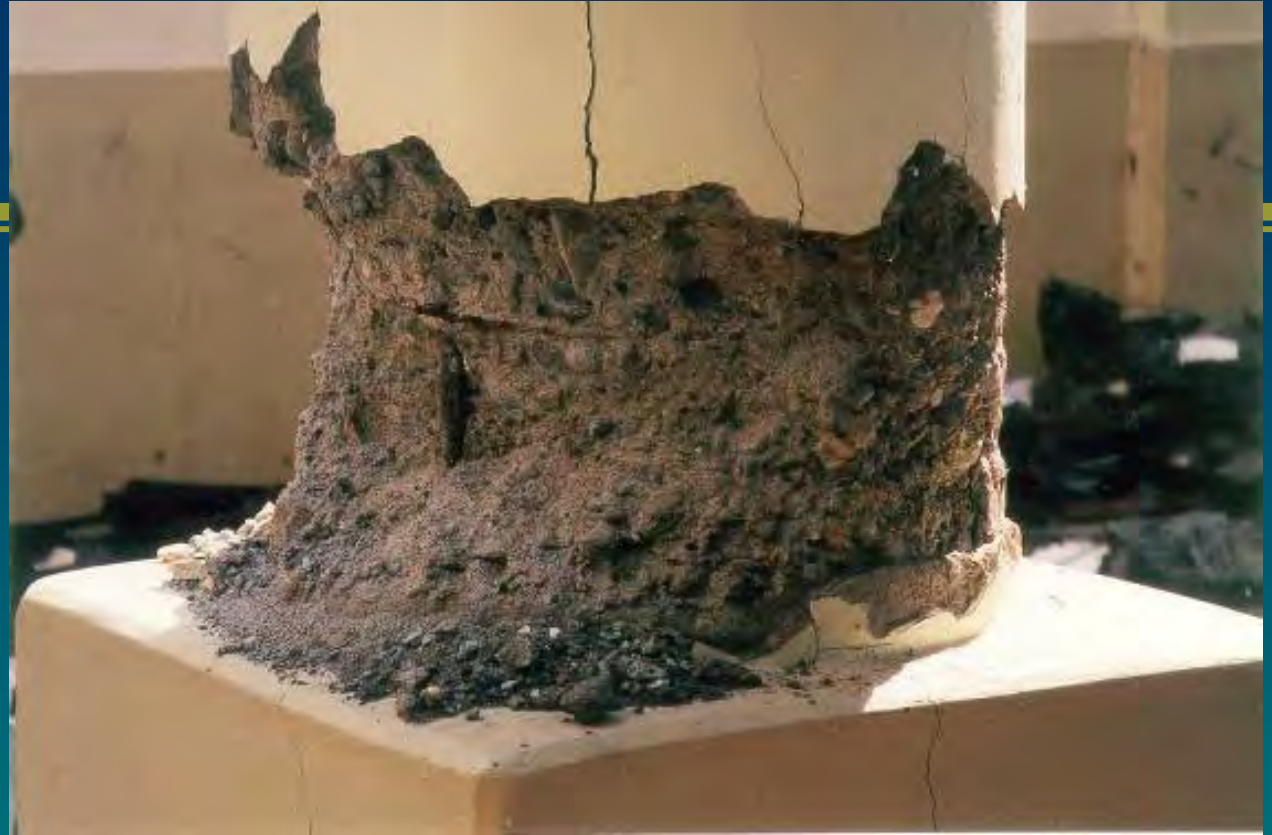
Concrete Quality

In some cases, high sand percentages were observed. Also, the gradation characteristics of the concrete mixes seem to be not complete. Both of these can lead to concrete of inferior strength and reduced ductility.
