Rapid Inventory of Earthquake Damage (RIED)

The 25 January 1999 Quindío earthquake in Colombia was a major disaster for the coffee-growing region in Colombia. Most of the damage occurred in the city of Armenia and surrounding villages. Damage due to earthquakes is strongly related to topographic and subsurface geotechnical conditions underneath structures and houses. The RIED project used aerial photographs to obtain a rapid inventory of the earthquake damage right after the seismic event. This inventory was subsequently used to identify any existing relation with subsurface- and topographic conditions.

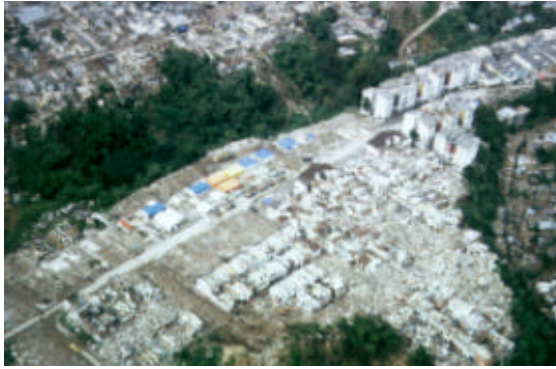
Photo 1. Neighborhood in the city of Armenia that was almost completely destroyed by the earthquake

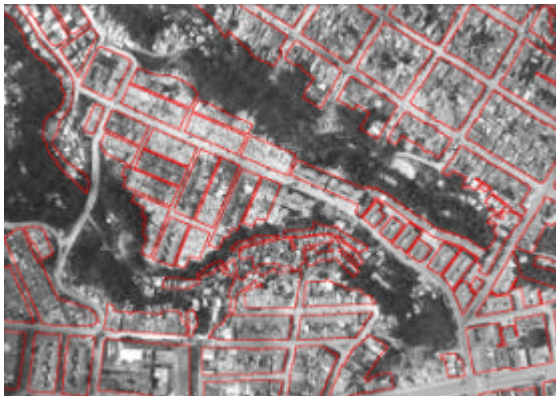
Figure 2. Digital orthophoto combined with existing cadastral data in the GIS

The aerial photographs were ortho-corrected (removal of camera- and topographic distortion) and with existing cadastral and topographic information a comprehensive Geographic Information System (GIS) database was set up in a short amount of time. The aerial photographs were interpreted in order to assess for each individual house or building whether it was damaged and what type of damage

was inflicted (see Figure 2). The damaged structures have been classified and marked on aerial photographs and simultaneously imported in a GIS. Maps for various types of damage to structures have been made and analyzed. In this way a large database was constructed with in total more than 33000 observations. An example of an analysis carried out on the basis of this damage inventory is given in Figure 3.

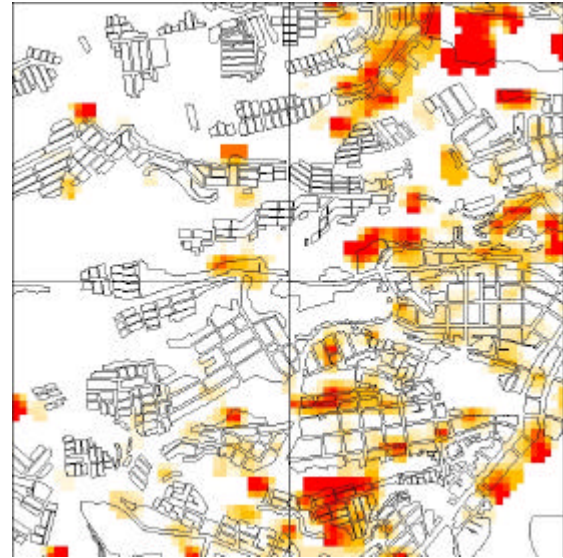
Figure 3. Damage intensity (damaged buildings as percentage of the total number of buildings)

The damage inventory made by aerial photographs clearly shows that the damage is concentrated in a more or less wedge-shaped area bounded by the Armenia fault on the East side and by alignments in the topography on the West side. The coincidence of this alignment with the boundary of the most damaged areas may indicate that the alignment in the topography is in fact a fault trace. The damage inventory shows further that topographical effects are of important influence on the damage inflicted on the surface structures. The apriory assumed influence of the landfills on the damage of structures is less obvious from the inventory by

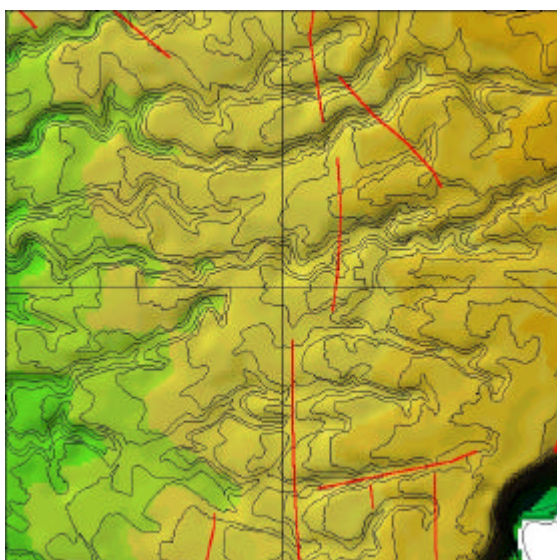
Figure 4. Topographic relief

The presence of topographic undulations (Figure 4) has a marked influence on the surface accelerations of an earthquake. Near steep slopes an amplification of the effects of an earthquake can be expected. Also resonance effects are possible if the dimensions of ridges in the topography coincide with the frequencies of the major tremor of the earthquake. The locations where this resonance effect may take place has been modeled in the GIS and an example of this analysis is given in Figure 5. Both topographic effects can be correlated to the damage patterns of the city of Armenia.
