Rapid Inventory of Earthquake Damage (RIED)

Assessment of the damage of
the 25 January 1999 Earthquake
in

Armenia and Pereira, Colombia

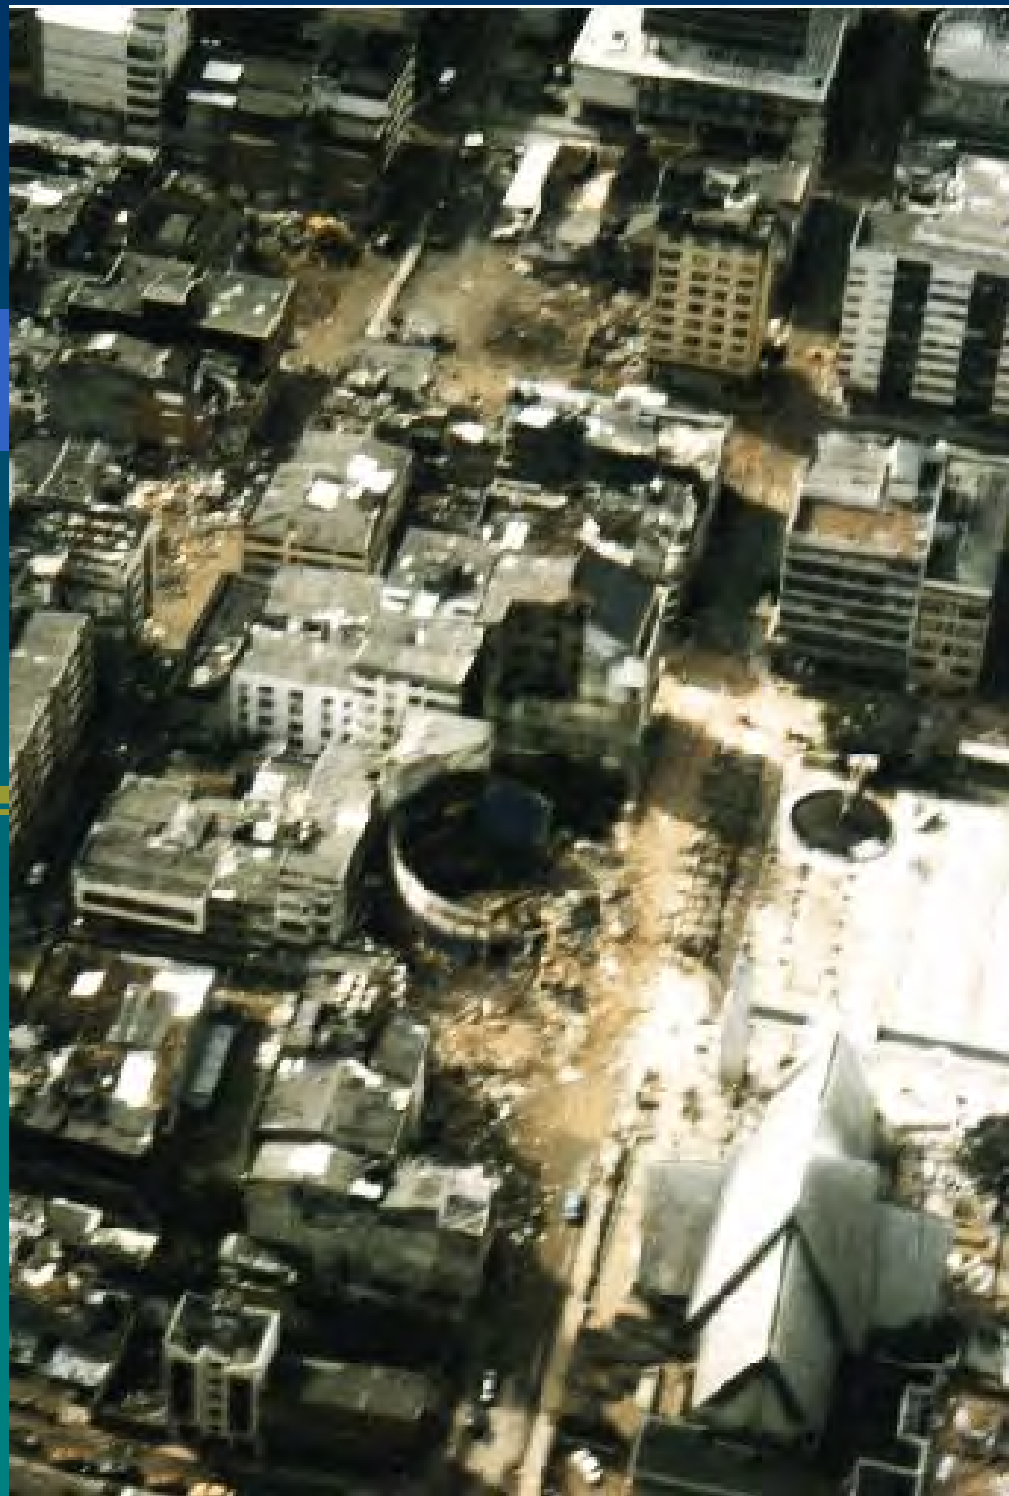
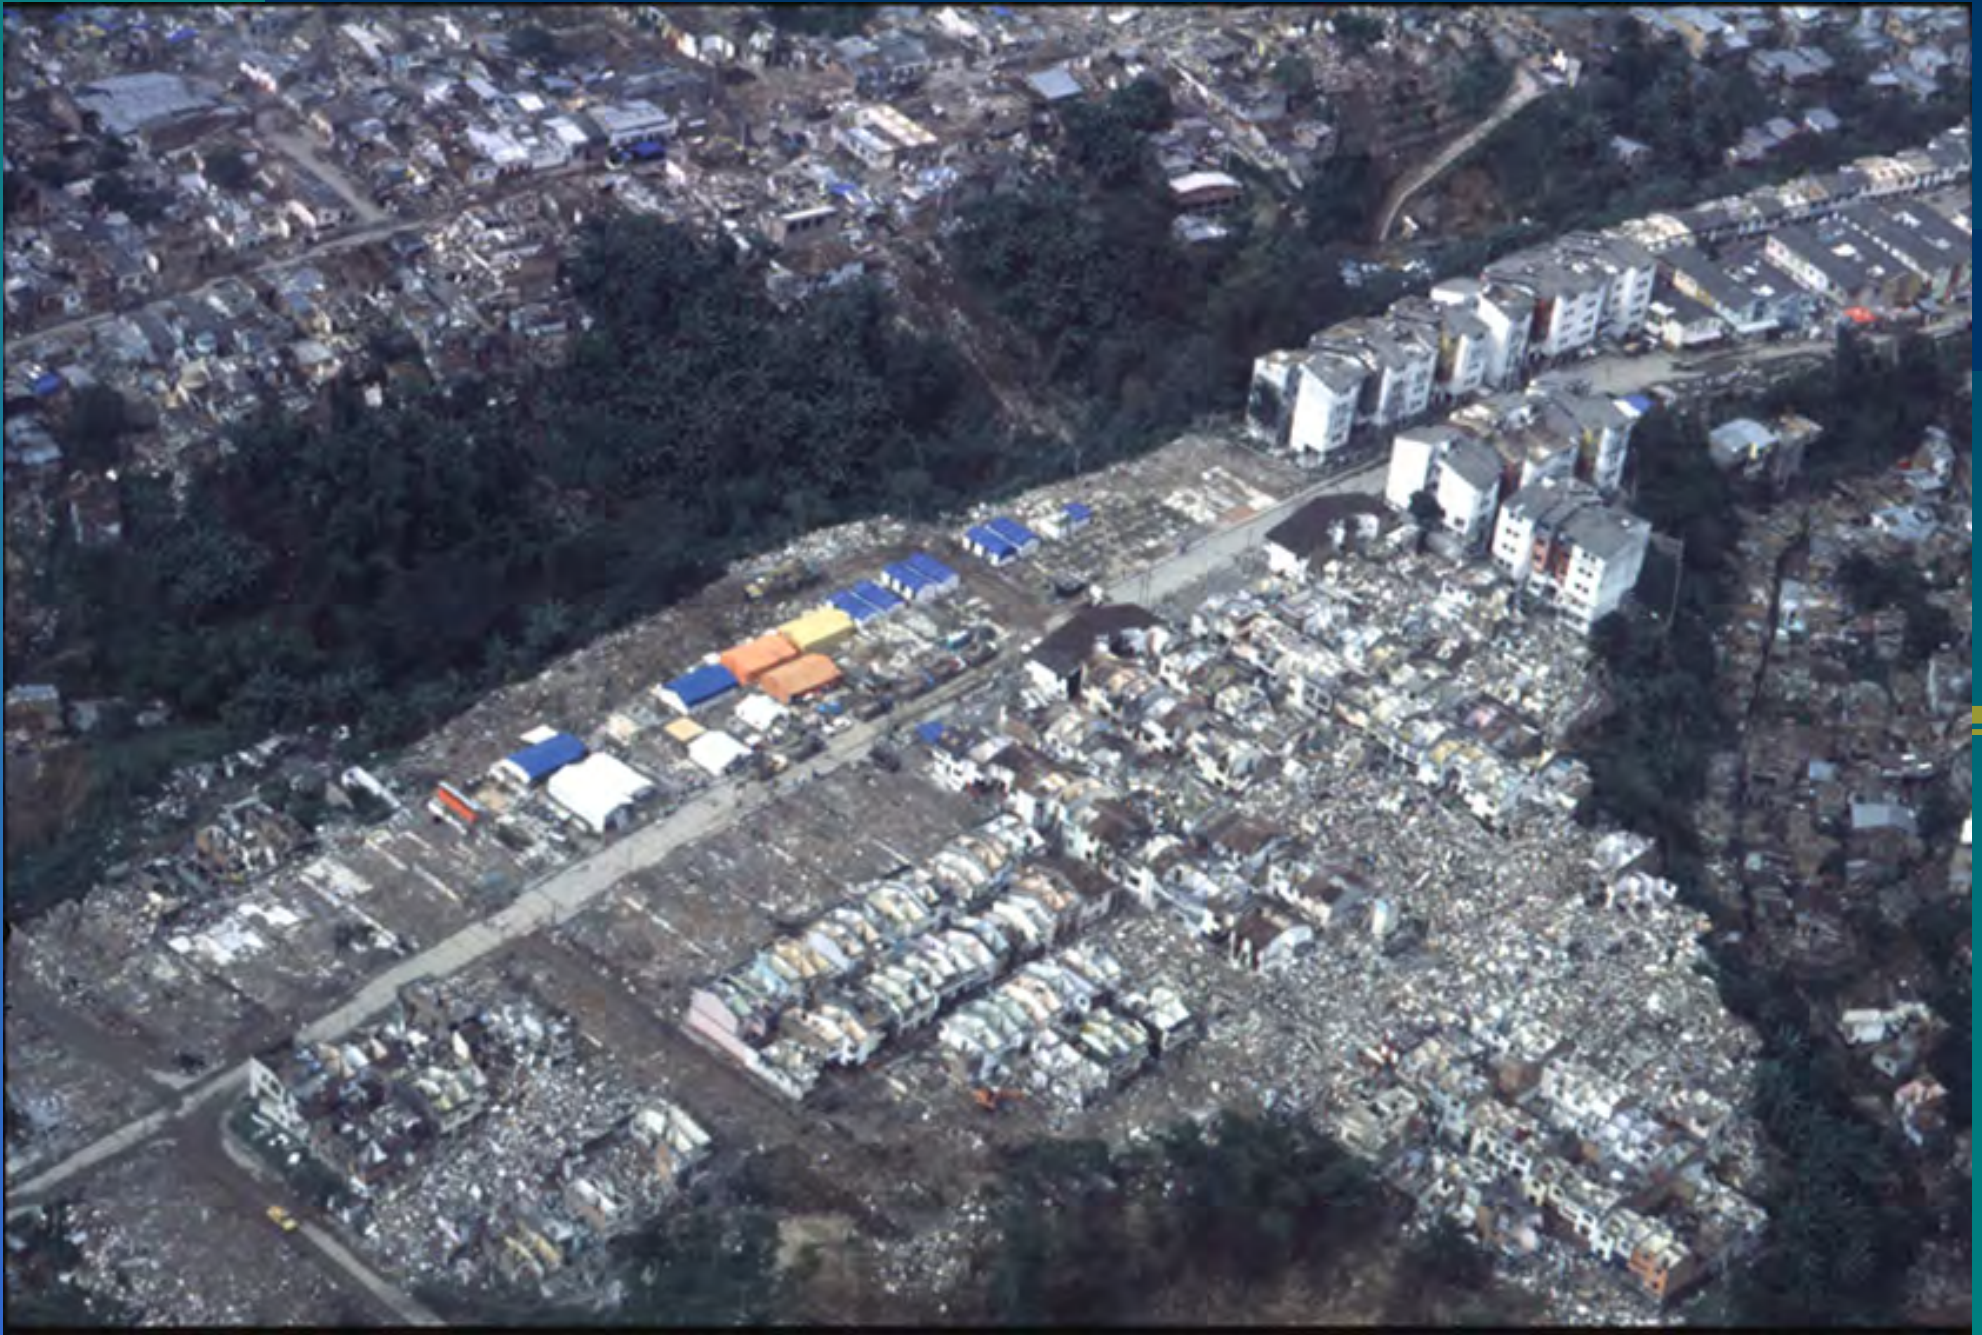
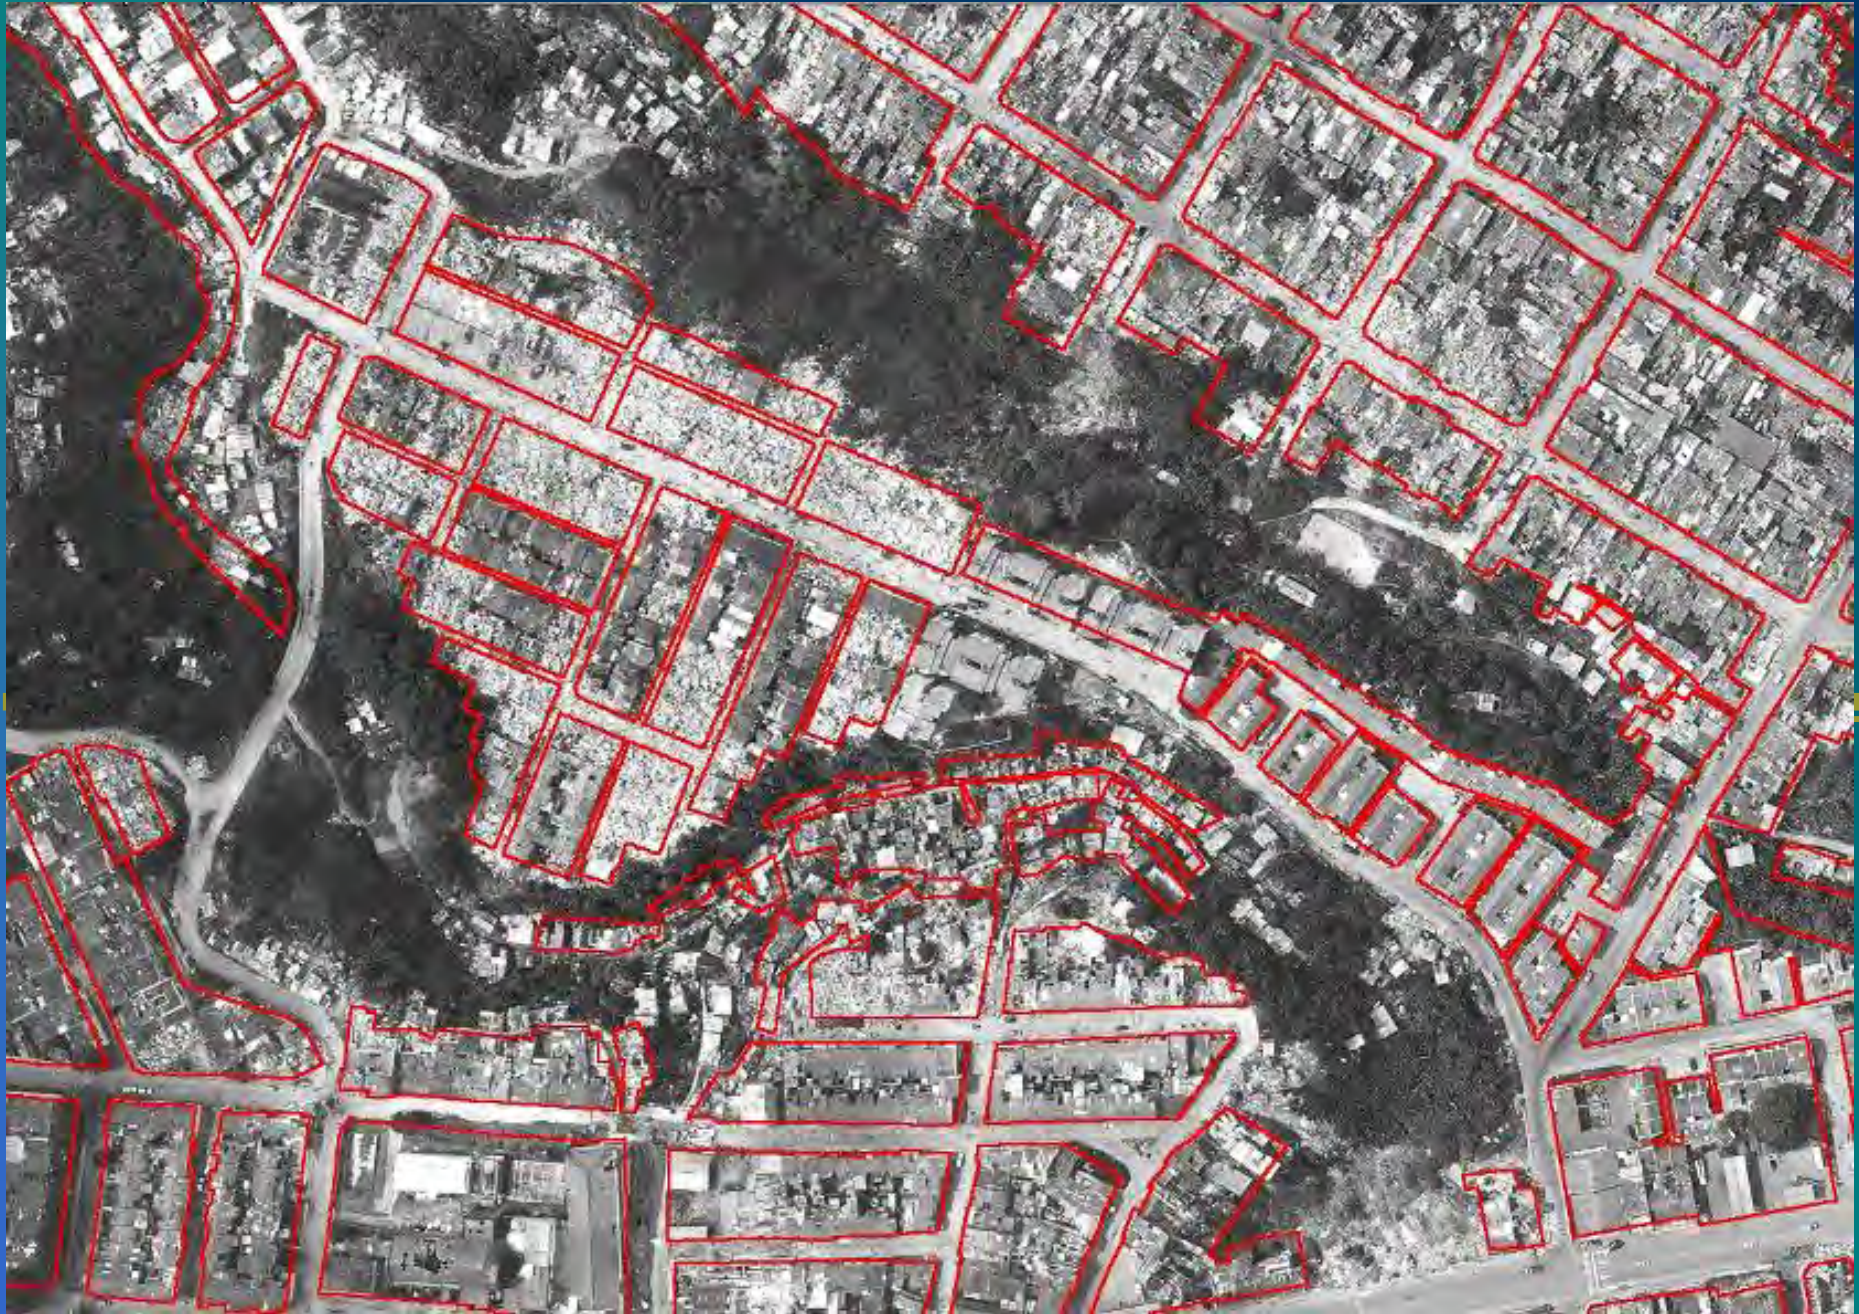
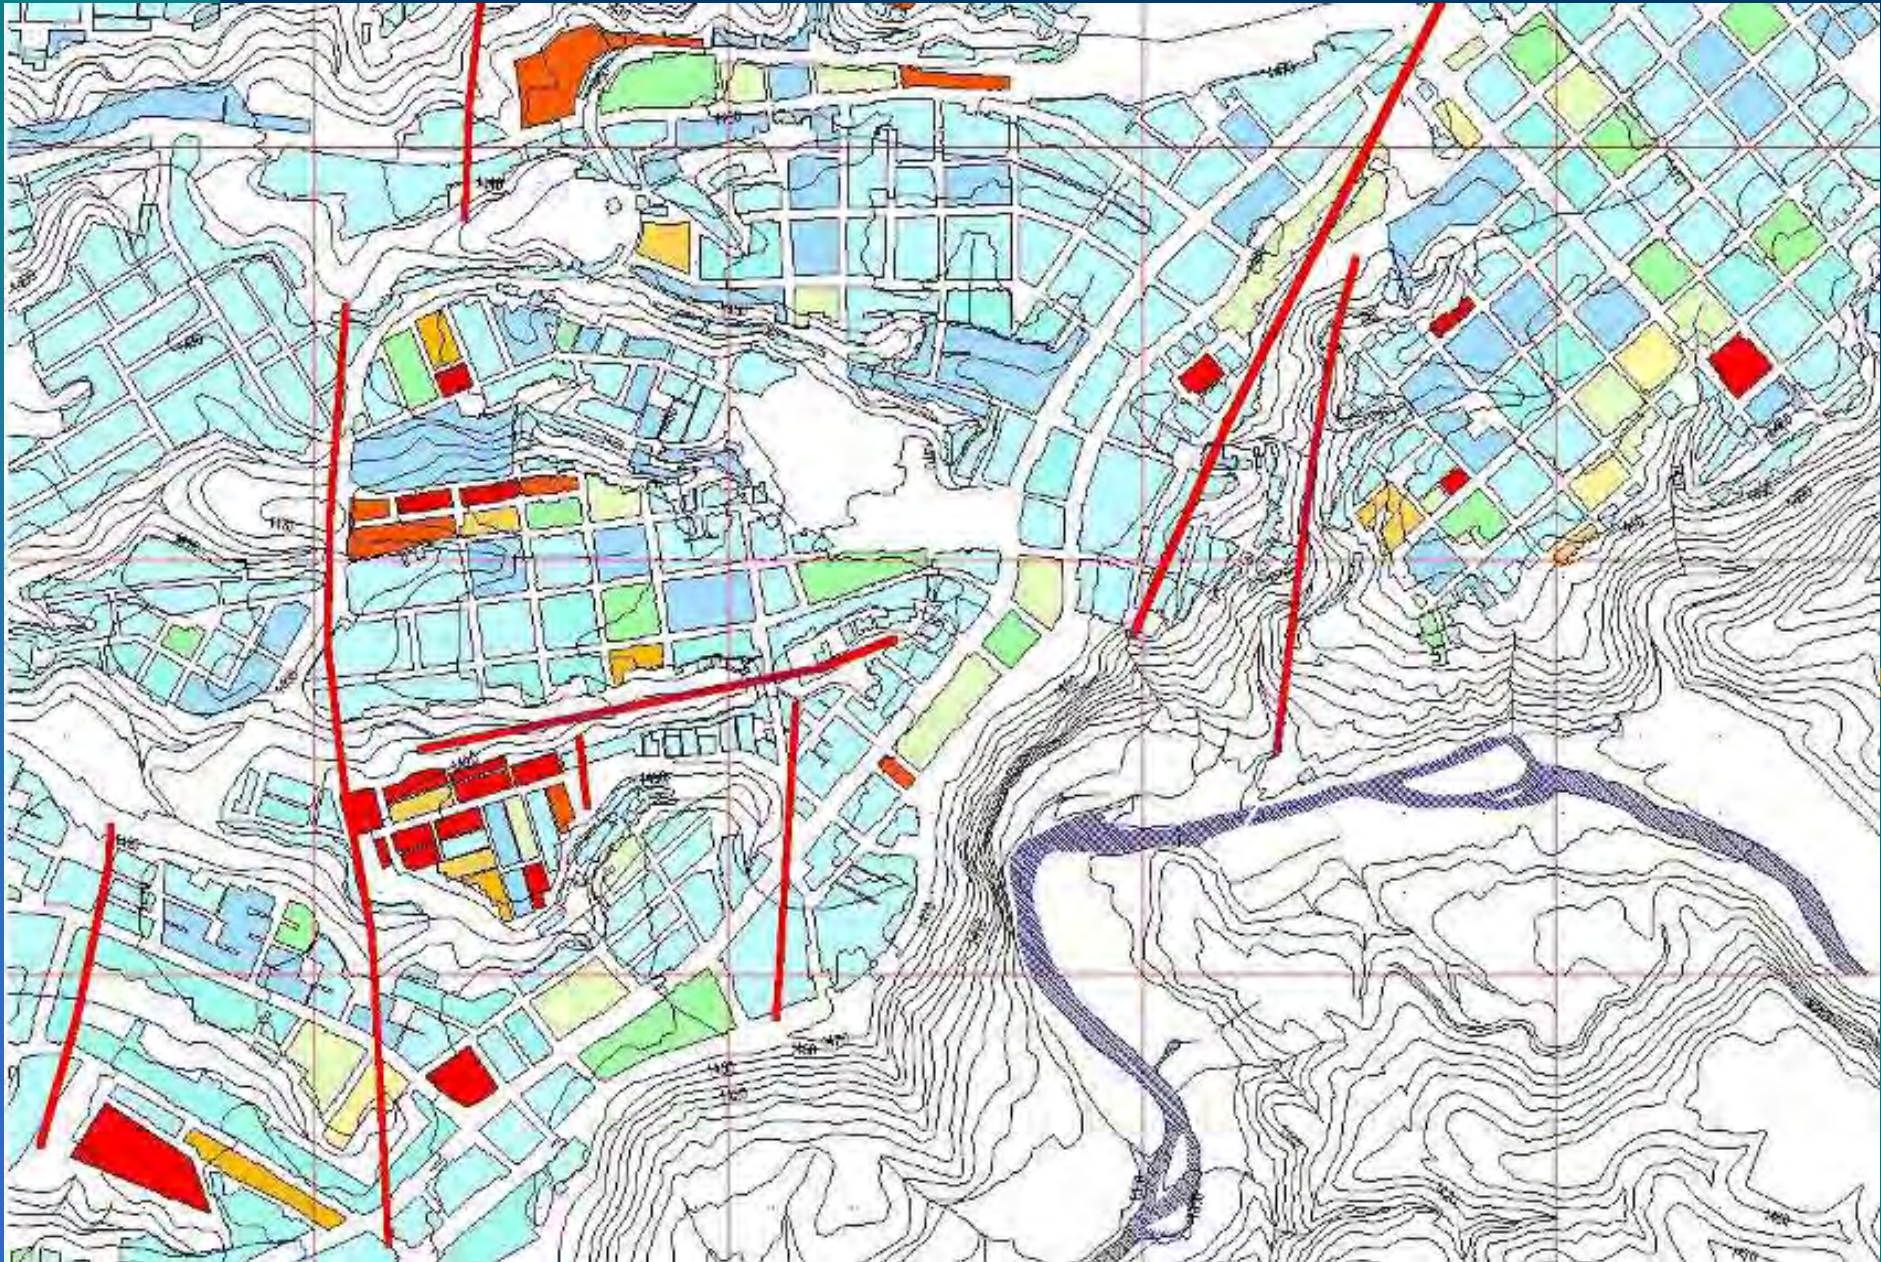
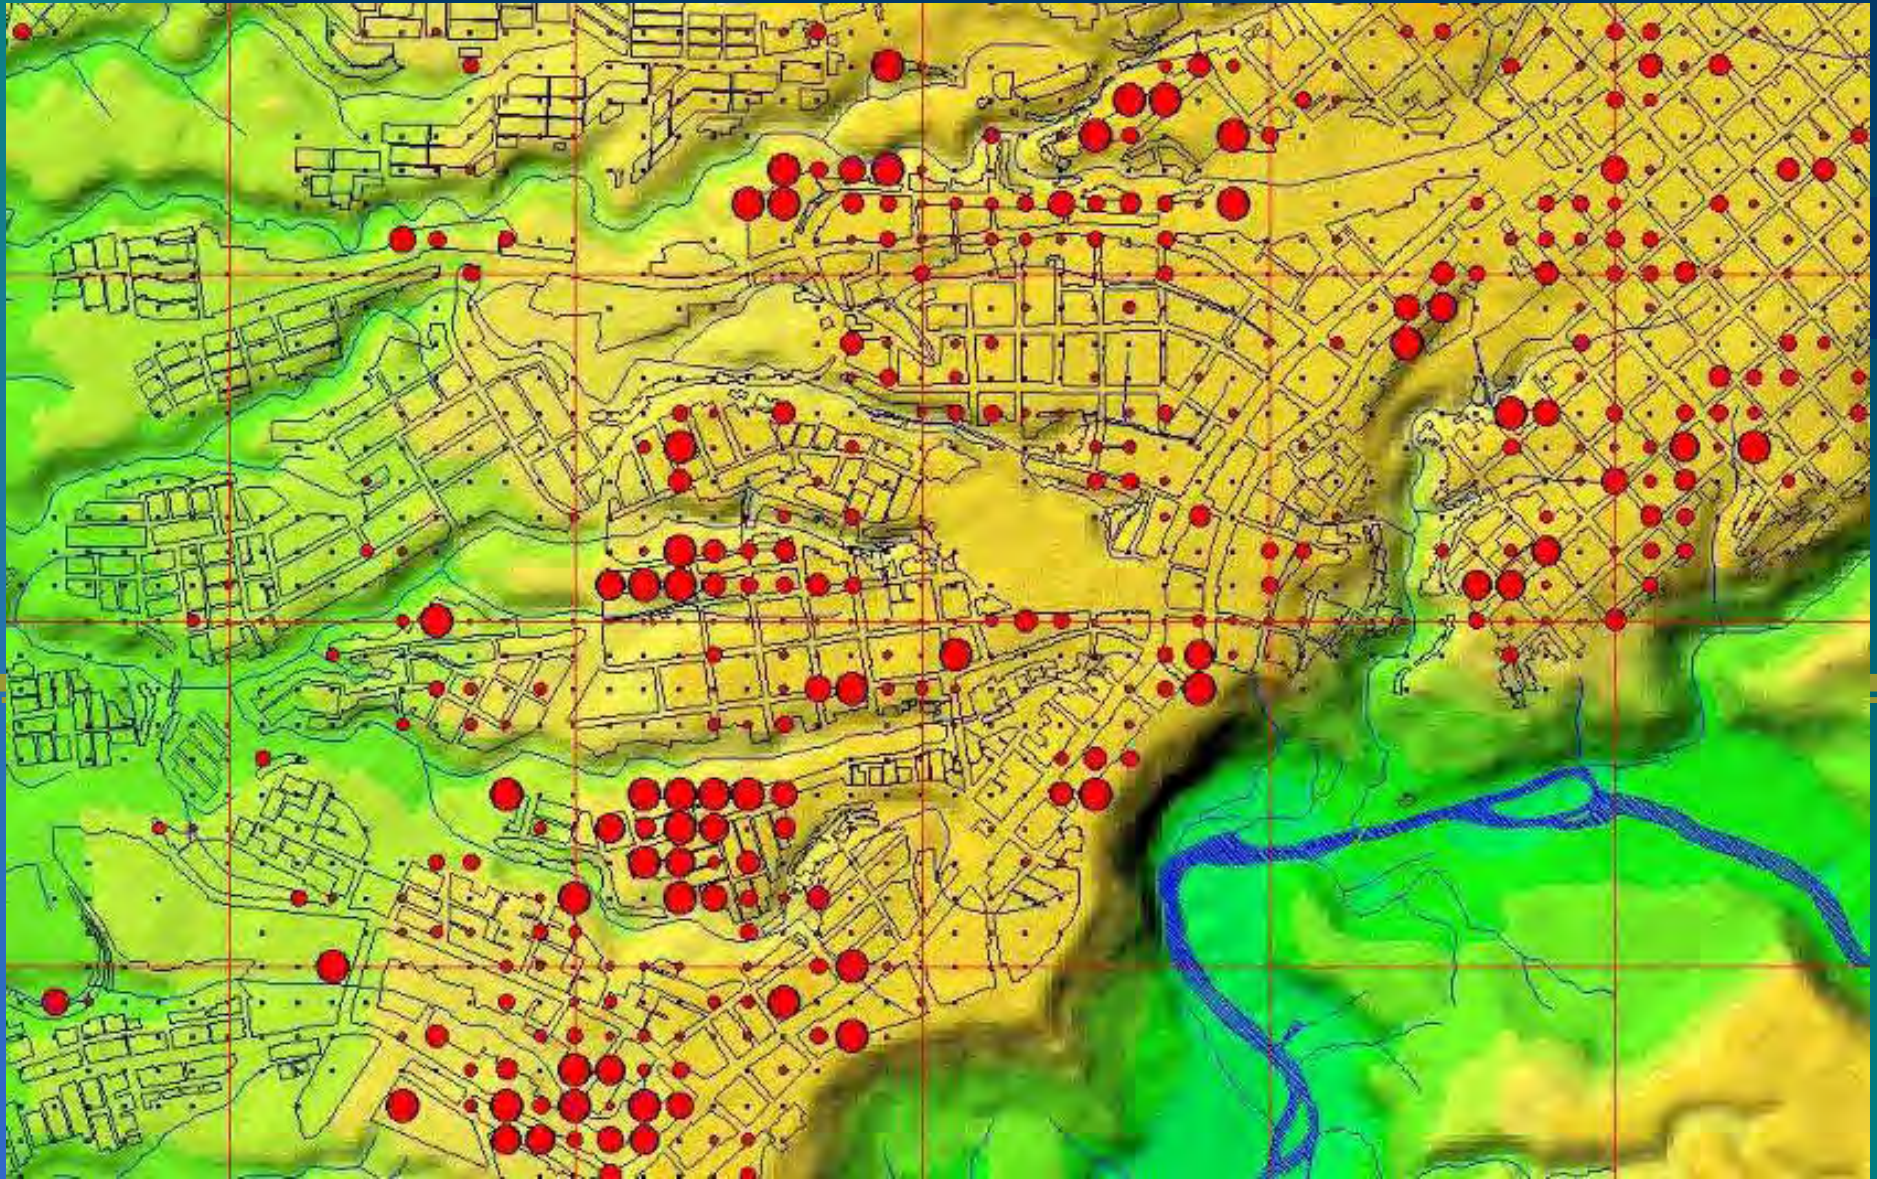
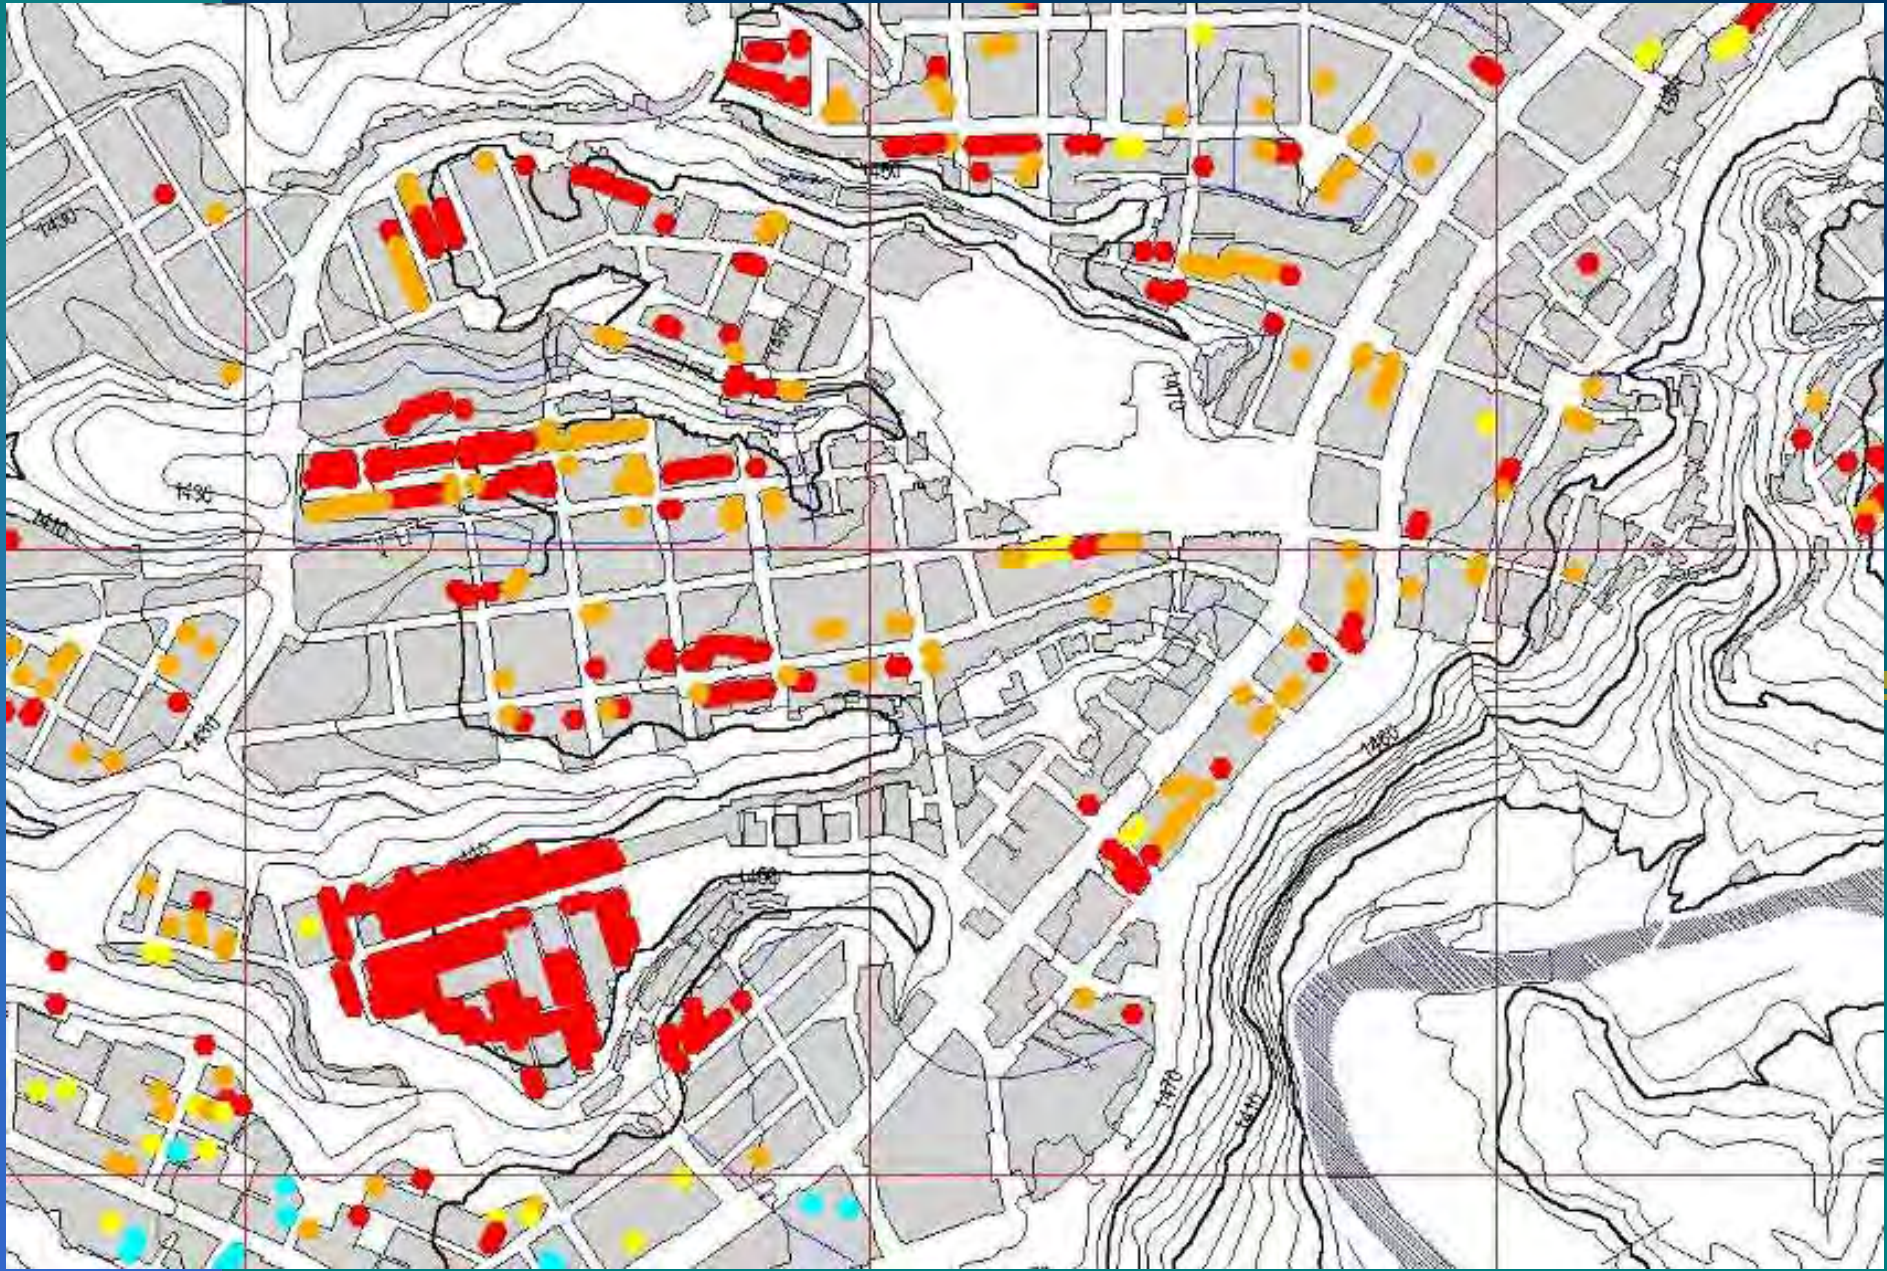
- Structures on aerial photographs were marked in 4 classes
 - Total Collapse
 - Roof Collapse
 - Roof Partly Damaged
 - No Damage Visible but Rubble in the Street
 - No Damage Visible

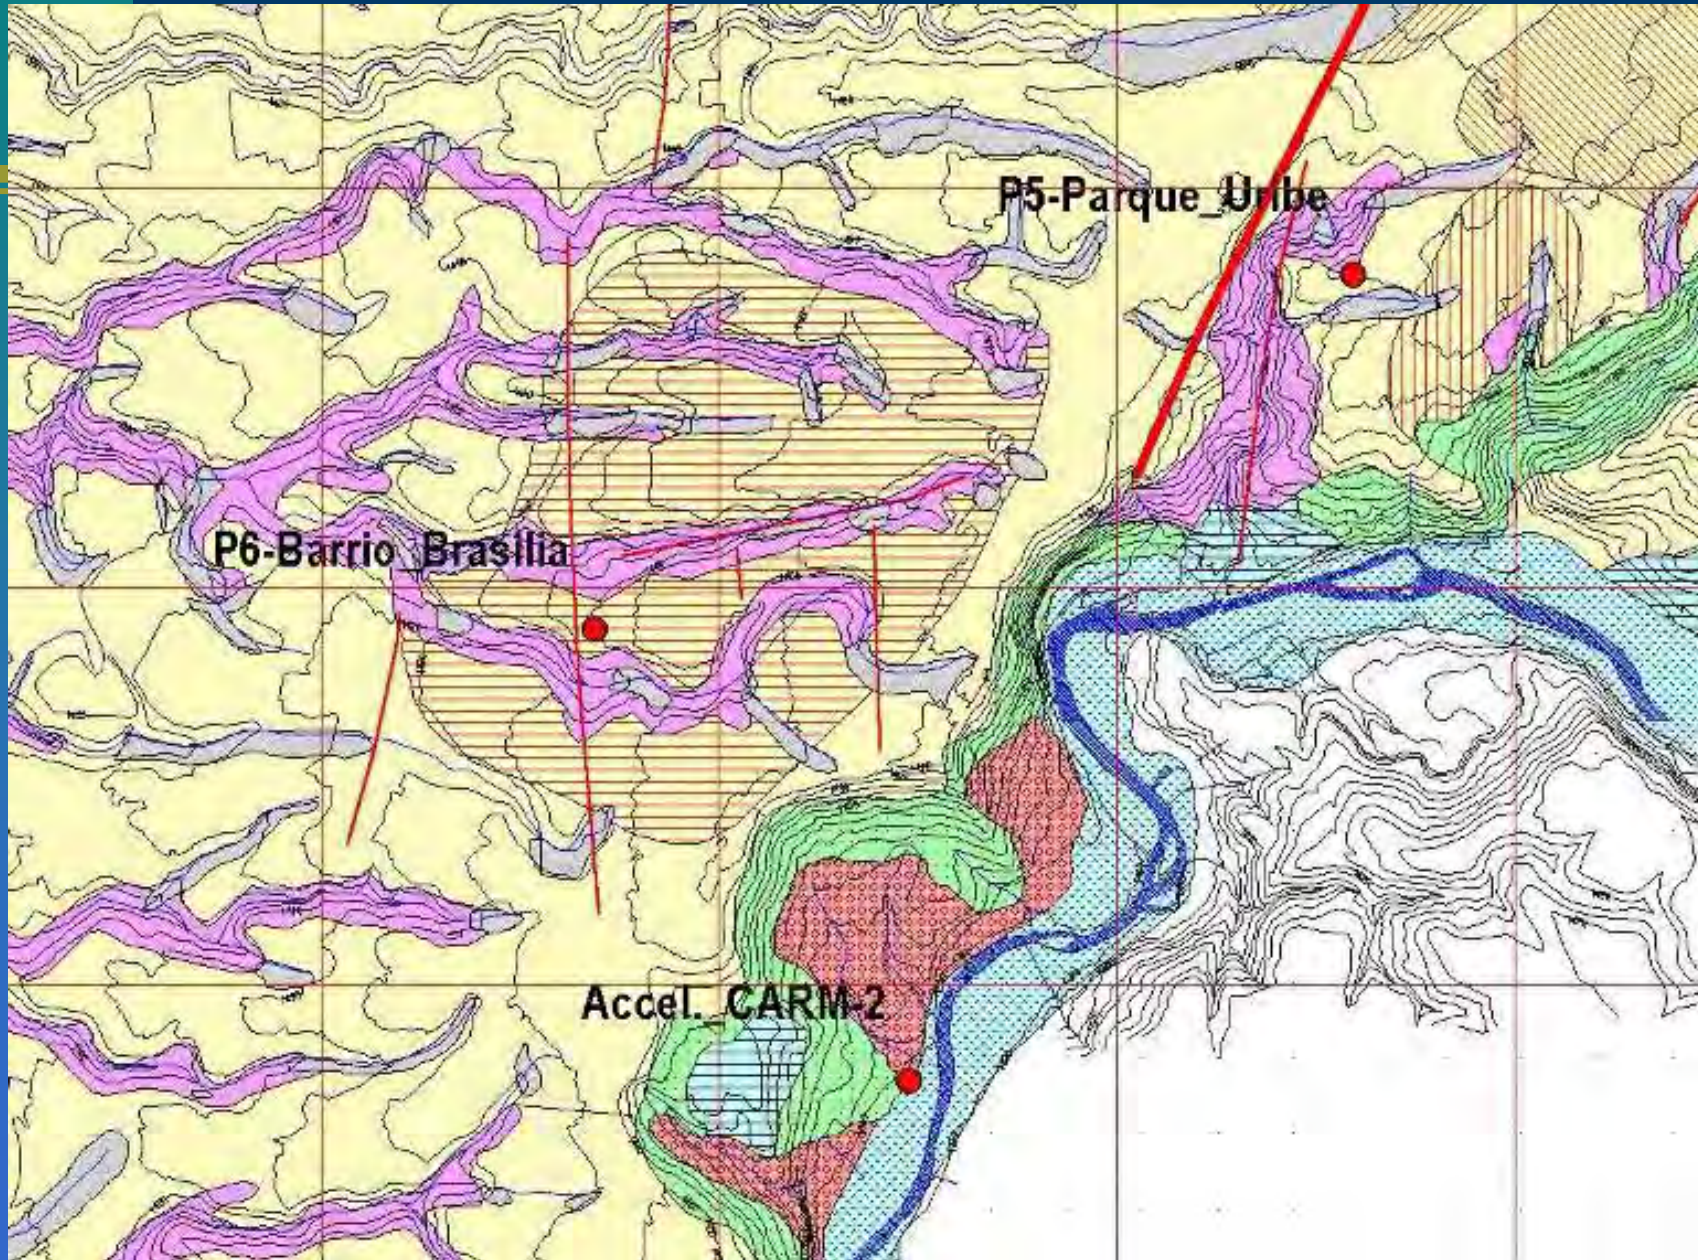
- Microzonation based on geotechnical model of sub-surface
- Coupling between GIS and Shake
- Automatic response calculation for each grid cell
- Dimensions grid cells 15 x 15 m
