Rapid Inventory of Earthquake Damage (RIED)

The 25 January 1999 Quindío earthquake in Colombia was a major disaster for the coffee-growing region in Colombia. Most of the damage occurred in the city of Armenia and surrounding villages. Damage due to earthquakes is strongly related to topographic and subsurface geotechnical conditions underneath structures and houses. The RIED project used aerial photographs to obtain a rapid inventory of the earthquake damage right after the seismic event. This inventory was subsequently used to identify any existing relation with subsurface- and topographic conditions.

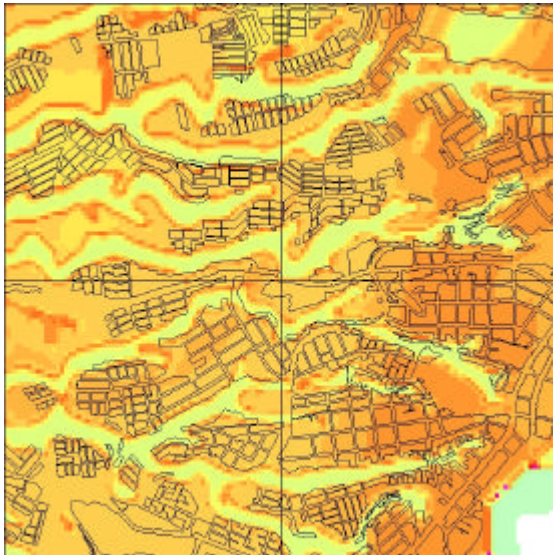
Figure 6. *Seismic acceleration response distribution for 1-2 story buildings*

model was constructed in the GIS which was subsequently used as input for the seismic response model. On the basis of the results of this seismic response analysis different seismic microzonation maps have been made which delineates the difference in seismic responses throughout the area as a function of the subsurface geology. Examples of these microzonation maps are given in Figures 6 and 7.
